WAUBEEKA LAKE DAM

CT 00065

PHASE I INSPECTION REPORT

NATIONAL DAM INSPECTION PROGRAM

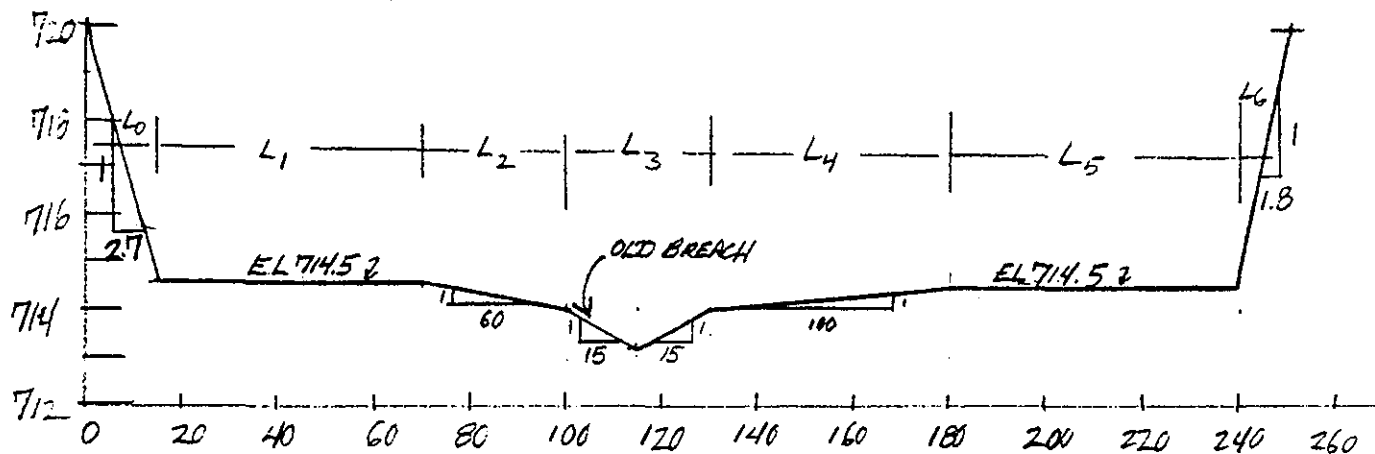
PROFILE ALONG ϕ OF EAST DIKE ESTABLISHED FROM DANBURY TOWN
TOPOGRAPHY, $1"=100'$, AND FIELD SURVEY MEASUREMENTS.
